MILLIKEN DAM : STRUCTURAL MONITORING OF A CONCRETE ARCH DAM

John F. Paxton ¹

¹URS Corporation, Oakland, CA 94607, USA; E-MAIL: John_Paxton@urscorp.com

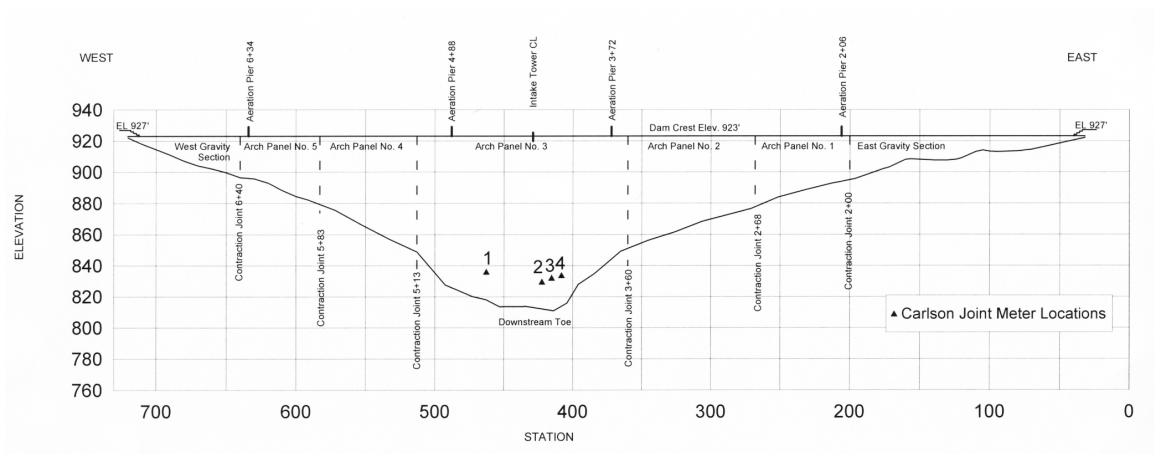
Figure 3. Developed Downstream Face Profile (viewed looking upstream). Meter locations No.1 and No. 4 have meter pairs at the upstream and downstream faces.

The monitoring system consisted of twelve Carlson joint meters installed in orthogonal pairs at six different horizontal crack locations, four on the downstream face and two on the upstream face. (See Figure 3, Developed Downstream Face Profile) Each meter pair was designed to measure vertical and upstream/downstream horizontal movement across the selected crack. The meters were installed in adits carved into the dam concrete so that the floor of the adit was a cracked (separated) lift line. The heavy gauge, multistrand cable attached to each meter was routed overhead to a shed on the right abutment above the dam containing the readout meter system. The Carlson meters functioned properly at first. Meter readings indicated crack changes were typically in the 0.01-inch range. The joint meters at Sta 4+66 (Elevation 835) showed larger movements than the other meters, with maximum meter readings in the 0.1-inch range. Also, the readings showed that most of the crack changes occurred during the uppermost 20 feet (6.1 m) of reservoir fill. After the first winter cycle, the upstream meters began to give readings indicating possible meter malfunction. The upstream meters were replaced the next year and the readings were continued. The meters and cabling system ultimately proved to be vulnerable to the elements. The replacement upstream meters showed signs of suspected water invasion after a few years. The downstream meter installations were repeatedly damaged by falling water and debris when the reservoir spilled. The upstream overhead cables were severed during high winds one winter shortly after installation. The cables were repaired, but the cables were not coded so it was never certain whether the meters were attached to the correct cable.

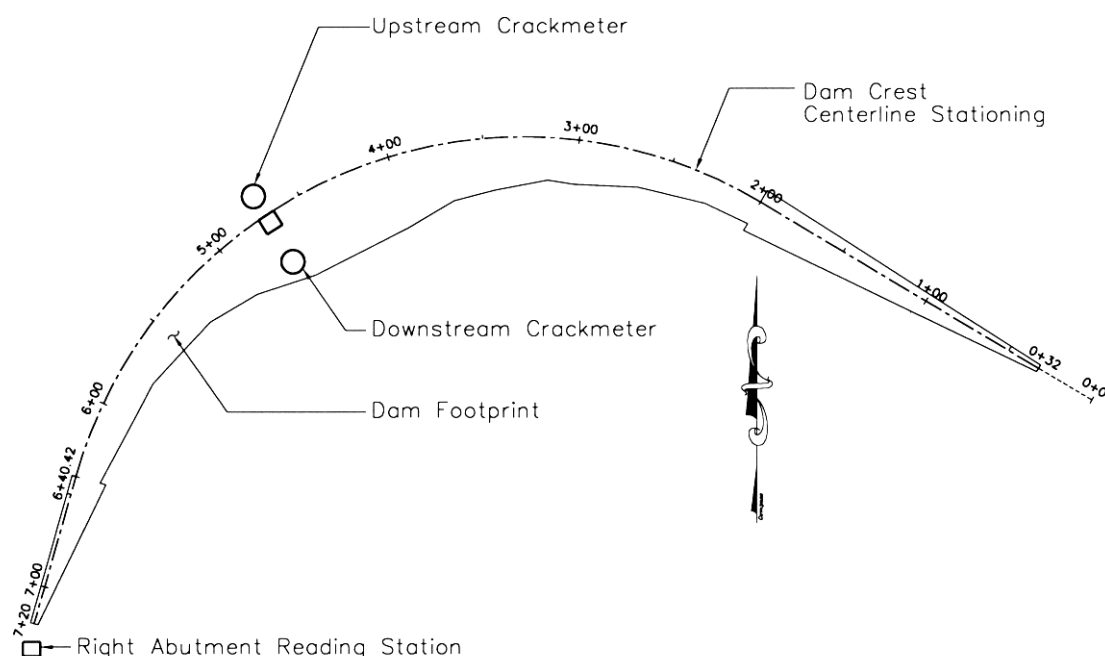
Figure 4. Crack Meter Installation Locations (1998)

The two meter pair locations that had measured the largest apparent deformations in the 1960's were selected for installing new meters (See Figure 4, Crack Meter Installation Locations). After evaluating several alternative designs, a meter design based on vibrating wire technology was chosen. Vibrating wire meters offered significant installation and operational advantages over the original Carlson meters: 1) Not affected by wire length adjustments, 2) Large measurement range combined with high resolution, 3) Stable meter calibrations (very low drift), 4) All stainless steel construction, 5) Designed for submerged operation.

The original adit cut into the dam for the Carlson meters was selected for the downstream meters. Most of the original installation at this location had been destroyed by falling water and debris.

To prepare the adit, the remaining filler concrete was chipped out and new holes were drilled for the threaded anchors used to attach the new meter assembly. A stainless steel mounting bracket assembly was fabricated and bolted into the adit to accept vertical and horizontal meters. A heavy-gauge stainless steel cover was then bolted to the dam concrete to cover the adit.

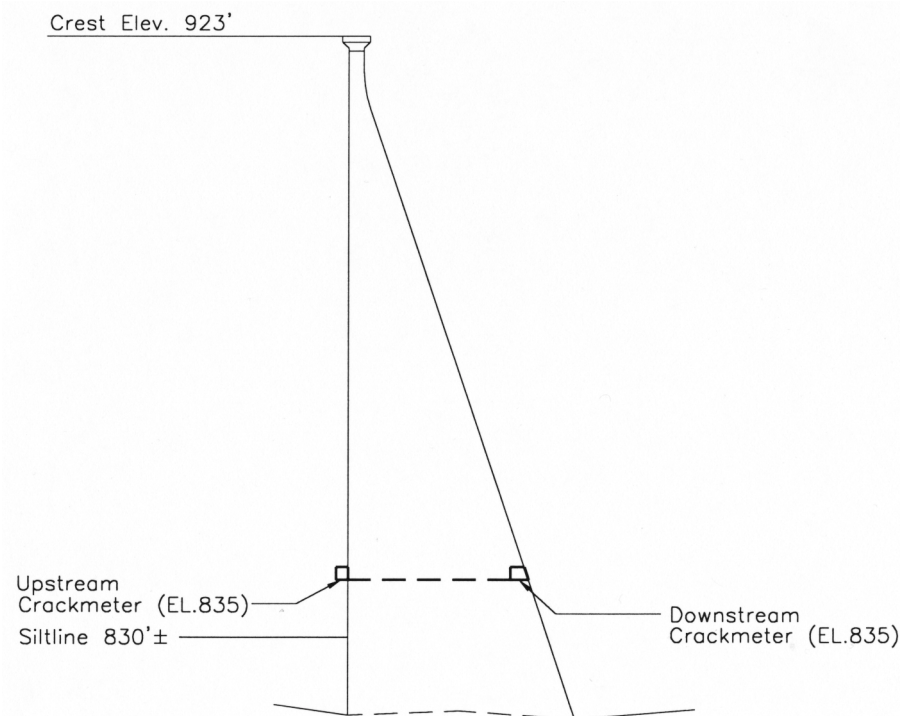
Figure 5. Profile of Milliken Dam showing new vibrating wire meter locations. The dashed line is the estimated location of the separated or cracked lift line.

Lowering the reservoir below the upstream meter elevation was not feasible, so the meter installation was planned using a diving team. The upstream meters were designed to be surface-mounted on the vertical upstream face of the dam since visibility was low. Working from a basic meter bracket design concept, Geokon developed a pre-assembled bracket on which the meters would be mounted and calibrated by the engineer at the surface. Using a special template, the divers installed eight stainless steel threaded anchors and then set the bracket assembly onto the anchors. After tightening the anchors, the two bracket halves were separated by removing the temporary straps.

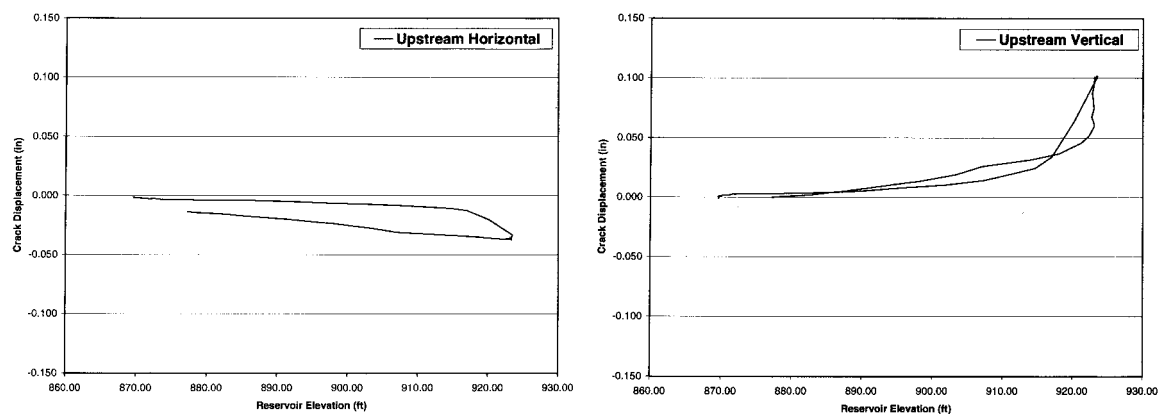
Figure 6. Upstream Vibrating Wire Crack Meter Readings. Horizontal displacements are on the left and vertical displacements on the right. Readings for the downstream horizontal meter are similar to the upstream meter readings.

Figure 6 shows the reduced temperature-corrected upstream meter data during the period of November 1999 to September 2000. The vertical meter readings indicate that the crack aperture increases about 0.1-inch (2.5 mm) at the upstream dam face when the reservoir changes from 869.5 ft to 923.1 ft. The upstream horizontal meter readings show the upper part of the dam moving downstream about 0.04-inch relative to the lower part of the dam. Most of the deformations occur during the last 20 feet of reservoir filling. This is a pattern observed in the previous meter readings as well as the current survey data. It is also interesting to note that, as the reservoir elevation declines, the meter readings do not follow the same path, giving the initial impression that the crack may not return to its original position at the beginning of the reading cycle. As the reservoir elevation declines, the meter readings appear to be returning to the previous initial readings. These patterns suggest that changes in the cracks for this reservoir cycle do not appear progressive.

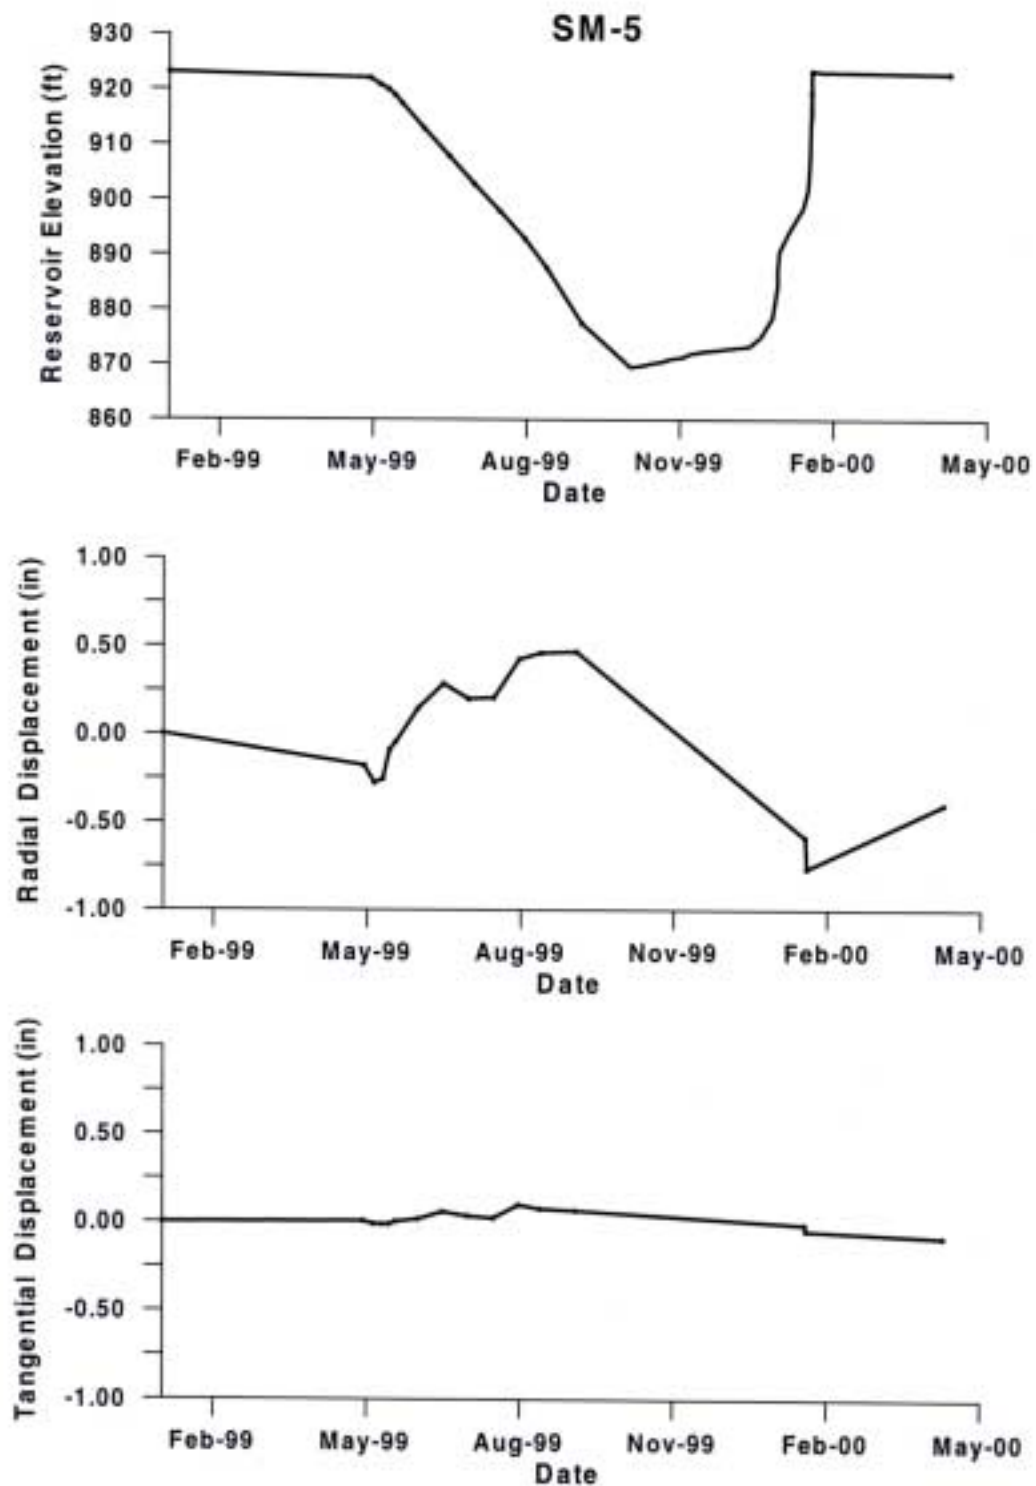
The City of Napa purchased a new Topcon GTS-311 automatic total station instrument in conjunction with the dam survey grid project. New survey grid baselines were established in January 1999. Since then, the grid has been surveyed more than 25 times over a range of reservoir levels. The survey data (originally collected as northing and easting data) has been reduced to radial and tangential vectors relative to the dam to better assess deformations. Figure 7 (following page) shows the radial and tangential data plotted for survey monument No. 5, near the center of the dam. The upper curve is a plot of the reservoir elevation over the period monitored. Note that the reservoir declines gradually during the spring and summer when water is being released through the outlet works. Reservoir fill is typically very fast as the plot shows in early 2000. The middle plot in Figure 7 shows the radial component of the survey data collected over the same period, ie. the component of the data in the direction of the center of the arch. The net downstream deflection of the crest at the survey monument is approximately 1-inch, similar to the deflections measured using the original lead tack survey points set flush in the crest of the dam. The third curve is the calculated tangential component of the survey data. This is the component parallel to the arch at the survey monument location. The tangential component of the data can be seen to be relatively small compared to the radial component, typical of concrete dams.

Figure 7. Survey Monument Reading Results at SM-5, near the maximum section of the dam.
