Presented at the FIG Working Week 2016,  
May 2-6, 2016 in Christchurch, New Zealand

# Terrestrial laser scanner for the deformations monitoring and buildings damage

## Case study: Burned industrial building

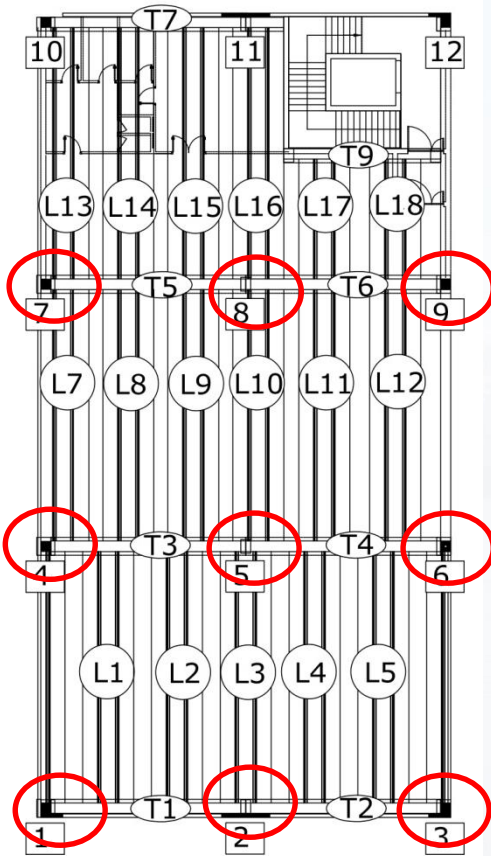
Structural elements scheme

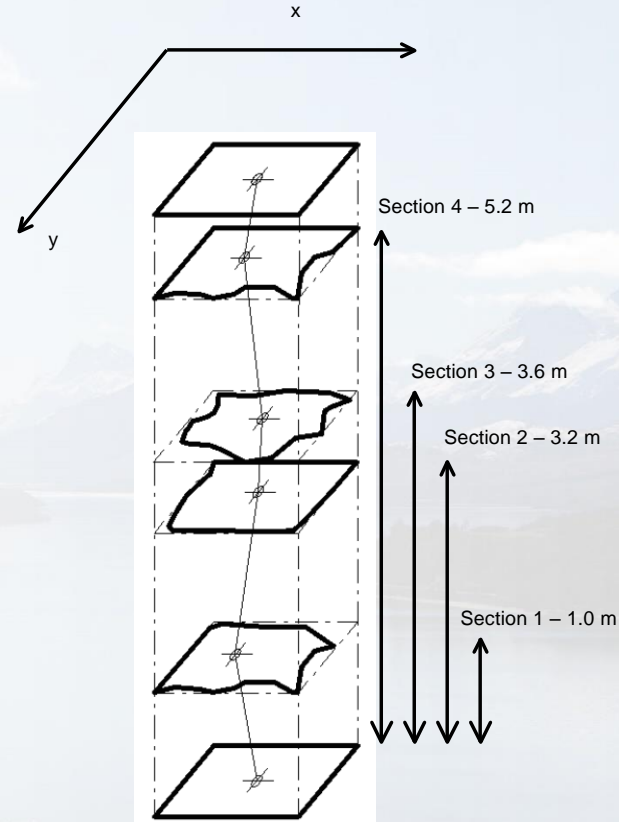
Scheme of the column cross-section center of gravity detection
