# APPLICATION OF SURVEYING TECHNIQUES FOR MONITORING AND APPRAISAL OF EXCAVATED CHINA CLAY SLOPES

John Coggan<sup>1</sup>, Doug Stead<sup>2</sup>, John Howe<sup>3</sup>

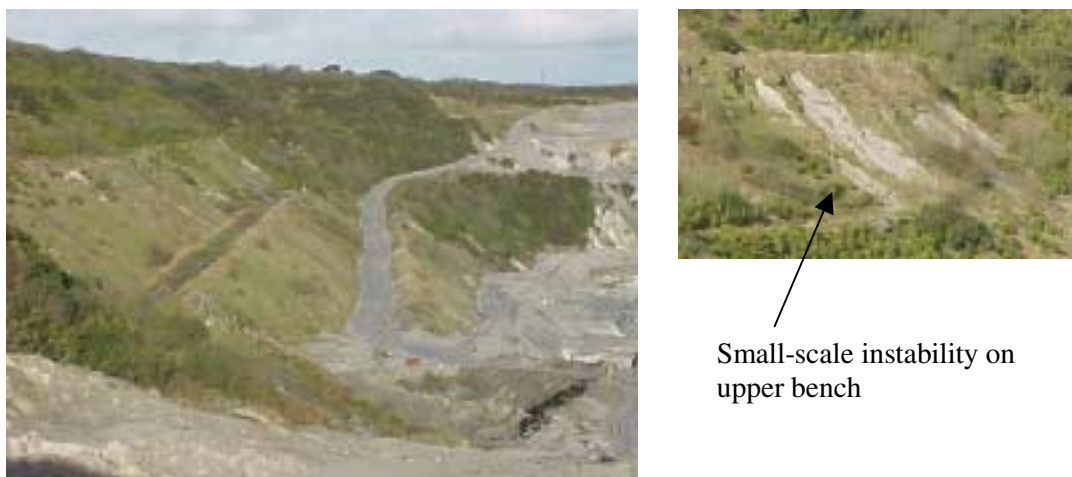
Figure No. 1 Images of western face where regular slope monitoring is carried

Regular slope monitoring of a critical section of an open pit has been undertaken since 1992. Figure 1 shows images of the western face of the monitored slope. An aerial view of the china clay pit is provided in Figure 2. The pit is currently 90m deep; elliptical in shape (900m long and 700m wide) with the long axis aligned north. The western slope contains highly kaolinised granite and has an overall slope angle of 26 degrees. Individual benches are 15m high, 12 m wide and have a bench slope angle of 40 degrees.

Lower section of the western face – looking in a northerly direction

instigated as part of a detailed geotechnical assessment of the western slope (Pine *et al.* 1994). Quarterly reading of the fixed targets have been taken since installation in 1992 using a Leica T2000 and electronic distance measuring system (EDM) semi-total station. 13 fixed targets are positioned at several locations on the slope (crest, upper and lower benches with lateral coverage). Within the overall accuracy of the measurements ( $\pm 5\text{mm}$ ) there has been no detectable movement relating to overall slope instability. Seasonal fluctuation has been detected; with expansion in the winter and contraction in the summer. Results from the regular monitoring provide confidence in the design factor of safety for the excavated slope. Small-scale heaving has occurred on several benches, such as that shown in Figure 1, but this appears to be isolated and controlled by structure (greisen veining).

The remote laser-based system has also been used to complement the more conventional precise slope deformation monitoring system, described in section 2; by providing additional visualisation of the minor small-scale heaving observed on several benches of the western slope of the china clay pit shown in Figures 1 and 2.

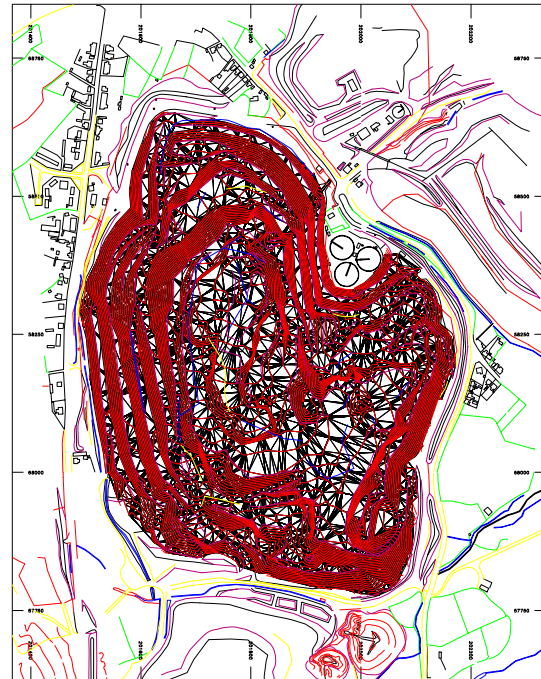
Figure No. 3 Digital terrain model (including surface topography)

Figure 3 shows a plan view of an example digital terrain model of the operational pit including key surface topographical features and elevation contours at 2m intervals. Following the methodology described the data is then filtered to eliminate slope elements below a specified angle. Figure 4 shows an image from the filtered digital terrain model highlighting specified slope elements with superimposed weathering grade. Figure 5 provides a three-dimensional block-model image of the western section of the china clay pit. From analysis of the digital terrain data, based on slope height and slope angle for a specific weathering class, it is then possible to determine whether or not the slope represents a significant hazard from a geometrical viewpoint.

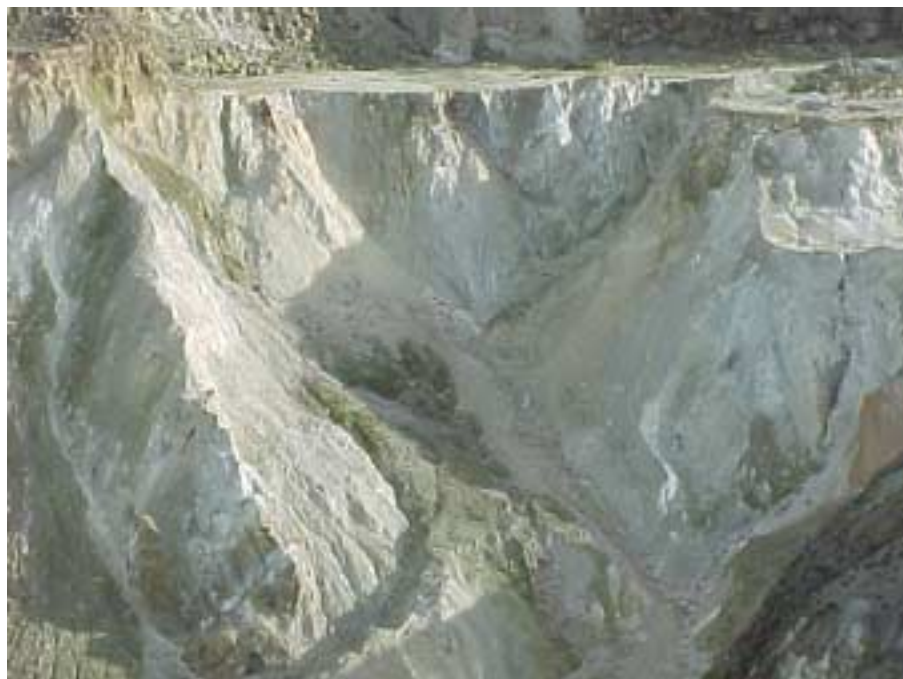
Figure No. 7 Photographic image of slope failure scar looking in an easterly direction.

The Quarryman ALS system has also been used to assist characterisation of the failure scar of a recent discontinuity controlled flowslide that occurred in an excavated china clay slope. The slope failure occurred on 31/10/98 following a period of prolonged rainfall and was associated with a 50m high slope that had an overall slope angle of 40 degrees. The overall slope contained a mixture of china clay matrix and sections of relatively unkaolinised granite. Further details of the back-analysis of the failure can be found in Coggan *et al.* (2000). Figure 7 provides a recent image of the failed slope. In view of difficulties with access the remote laser-based system proved extremely useful in providing geometrical data relating to the failure. The accuracy of the device (5cm over 300m in reflectorless mode) was considered sufficient for the application.
