Presented at the FIG Congress 2018,
May 6-11, 2018 in Istanbul, Turkey

Investigation on Appropriate Surveying Method Following the National Disaster Damage Investigation System

10th of May, 2018
Istanbul Congress Center

[BongBae, JANG
JuneHwan, Koh] Republic of Korea

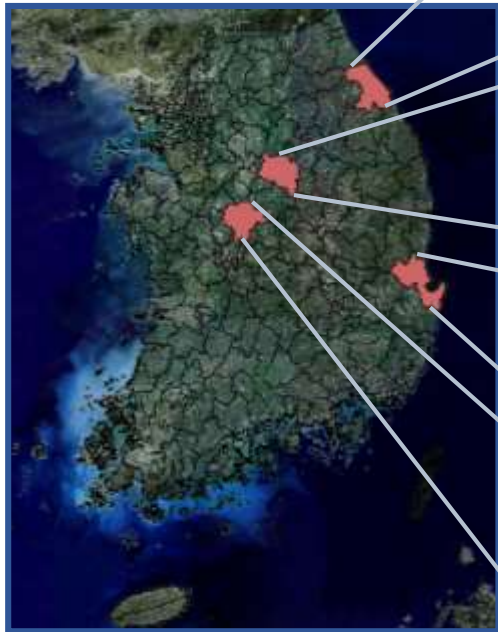
Type of case studies

Forest fire

17.05.06.
Gangueng

Hail

17.09.19. Choongju

Earthquake

17.11.15. Pohang

Mountain landslide

17.07.16.
Choongju

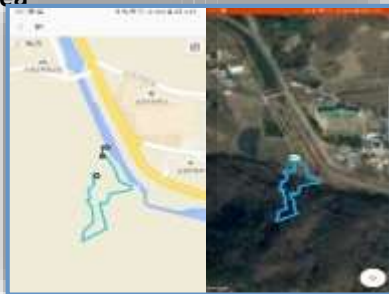
**[Method I]
Tracking App**

Utilize App -> measure destroyed area

Time	26min/ 3min
Area	3,000m ²
Difference	-339m ²
Result	Rapid info. No Equipment

For the landslide disaster four different methods were compared and analyzed.(APP, TS, RTK, UAV)

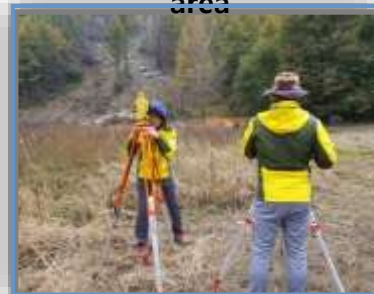
**[Method II]
T/S**

Measure Destroyed area

Time	58min/ 7min
Area	3,339m ²
Difference	Standard
Result	Difficult measuring

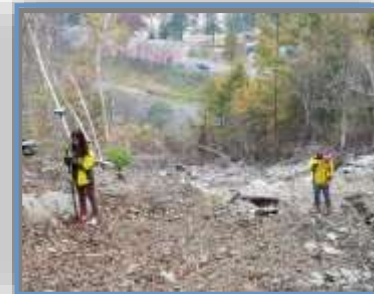
**[Method III]
RTK**

Obtain coordinate

Time	37min/ 15min
Area	3,454m ²
Difference	115m ²
Result	Multipath

RTK is the most suitable method (Direct measurement method with rapid and good accuracy)

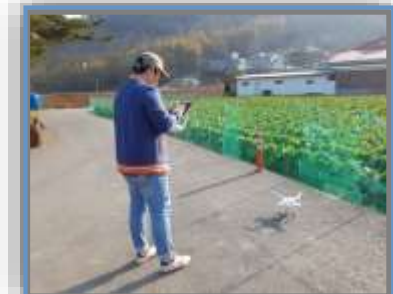
**[Method IV]
UAV**

Acquire Ortho-photo

Time	28min /240min
Area	3,622m ²
Difference	283m ²
Result	Safe location various uses

UAV provides a highly accurate ortho-images and can be used for various disaster monitoring

UAV is one of the most effective and efficient methodologies for landslide

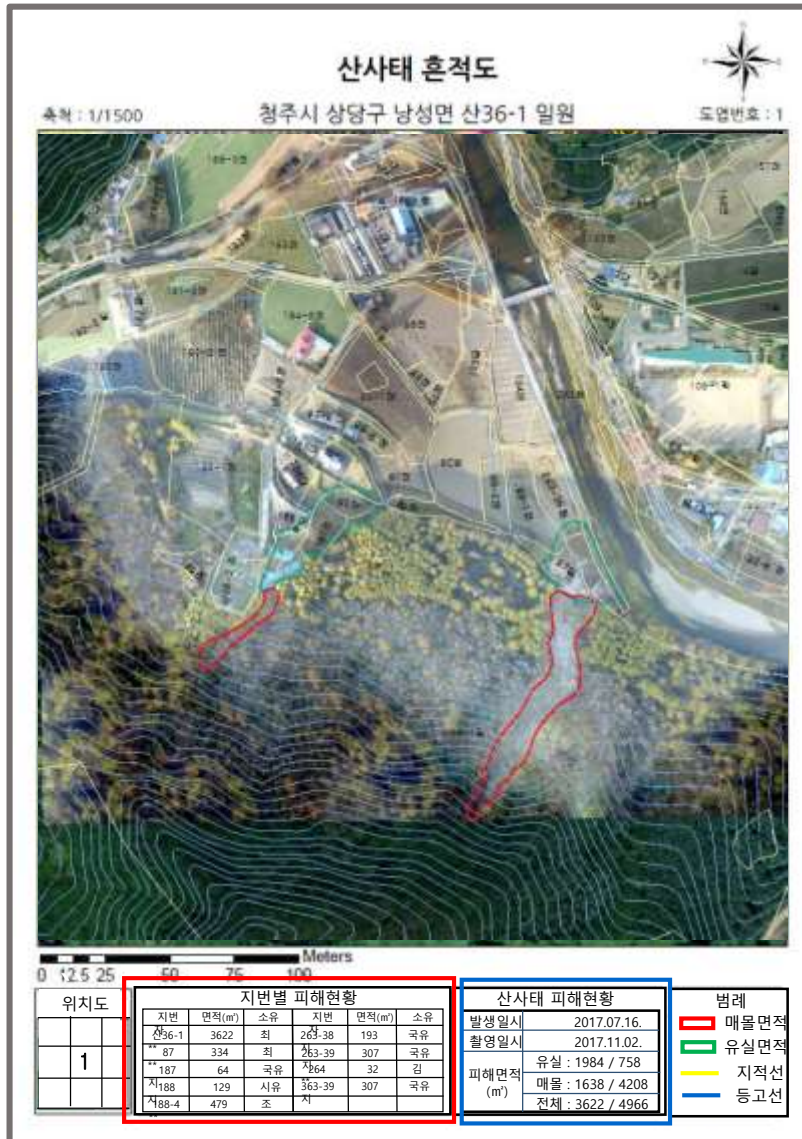
<산사태 흔적도 정보>

2. Landslide Maps

① Attribute data

- Orthphoto, 3D Image, Video, DATA of destroyed areas

산사태 피해현황	
발생일시	2017.07.16.
촬영일시	2017.11.02.
피해면적 (m ²)	유실 : 1984 / 758 매물 : 1638 / 4208 전체 : 3622 / 4966

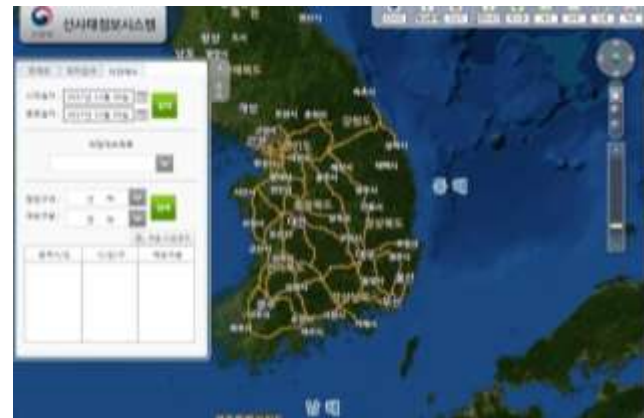
<Landslide Information System>

② Application

- Report to VIP
- Data Upload in Real-Time level
- Masterplan for Damage reduction
- Certification for damaged

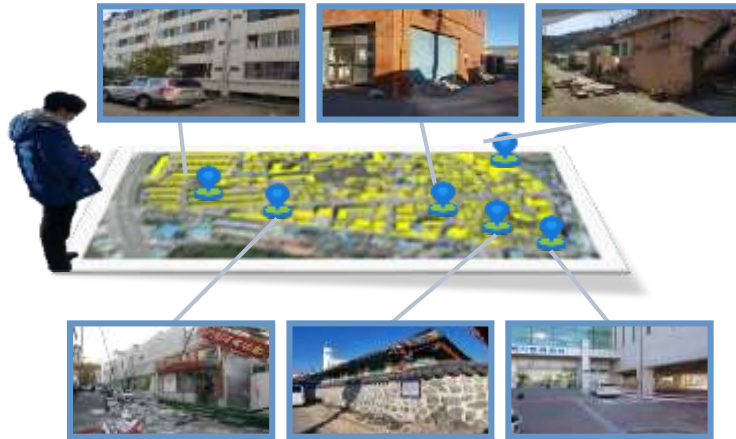
① Analysis of current and further damages

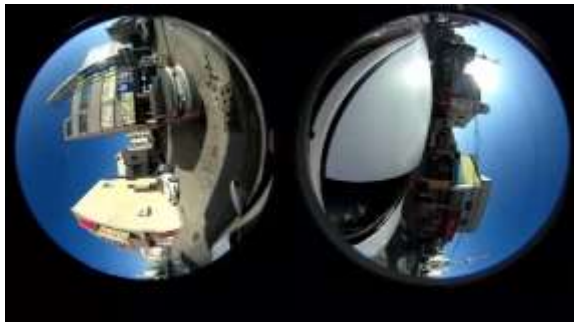
② Video and Photos for data acquisition

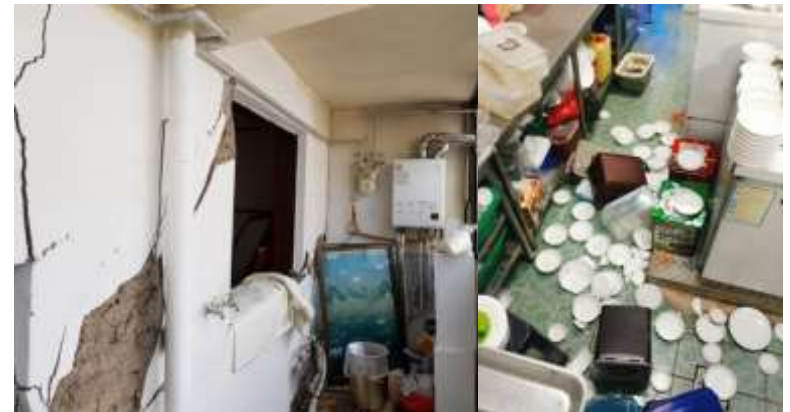
① Interview for residents

Personal	name	sex	age	Residence peood	Address
Date	이 * 구	남	60대	30년 이상	흥해읍 흥해로 88
Contents Of Interviews	Date				17.11.15.
	Location				북구 흥해읍
	Cause of Damage				지진파 증폭
	Damage Condition	인명피해			경상 2명
시설물			집기류, 벽체 파손		
농경지			해당사항 없음		
기타			벽체 갈라짐		
Opinion	피해단계 4 극심 예상

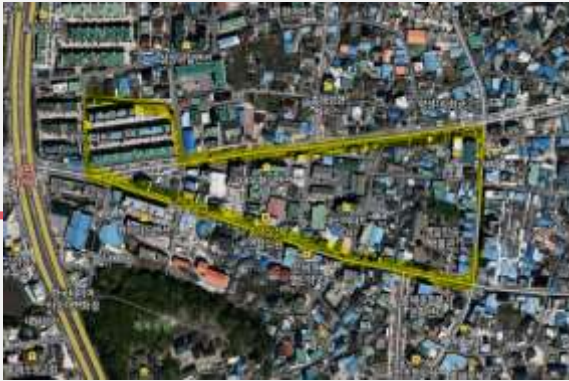
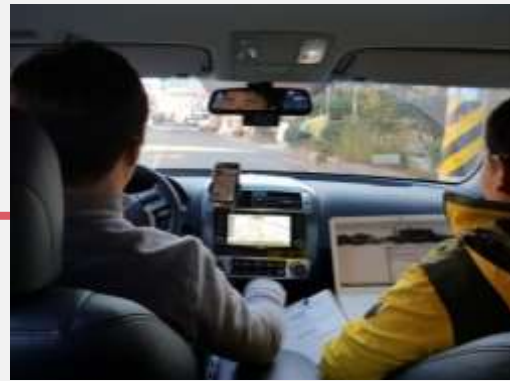
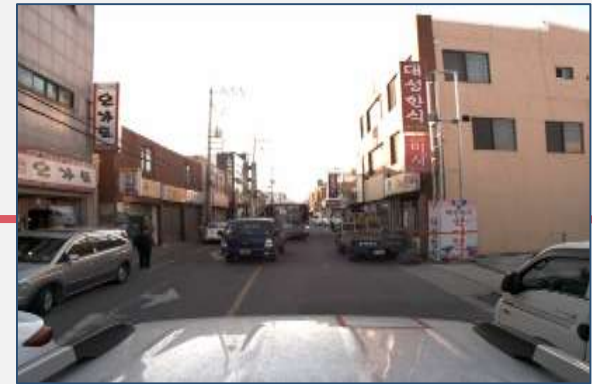
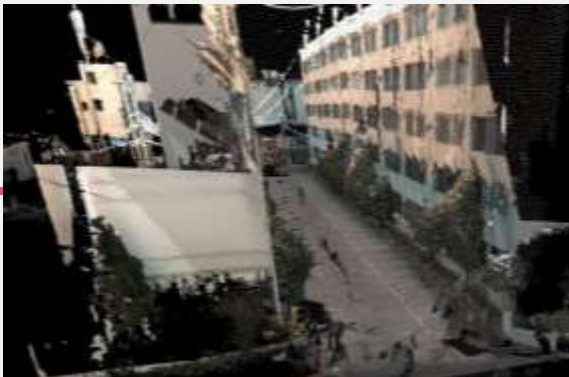
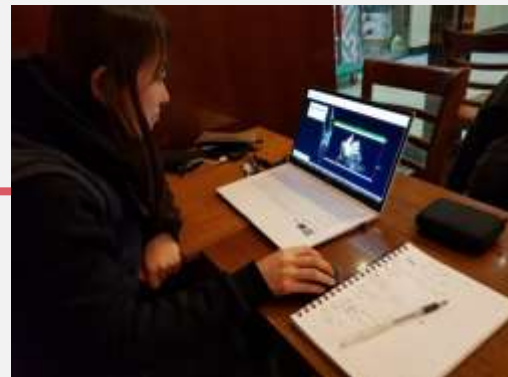
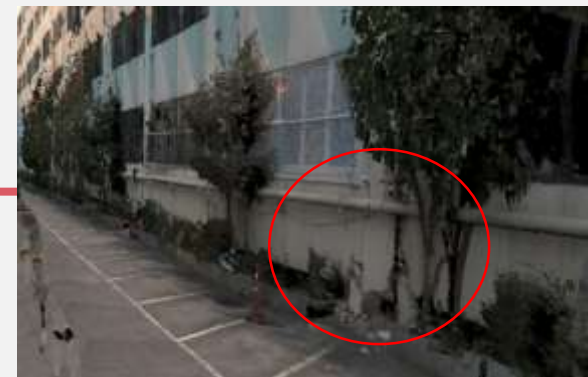
MMS procedure

① Decide area

② MMS driving

③ Acquire image

④ scanning(Point cloud)

⑤ processing

⑥ results

*MMS(Mobile Mapping System) : rapid data acquisition method for 3D images with Camera, Laser scanner, GPS, INS, etc.

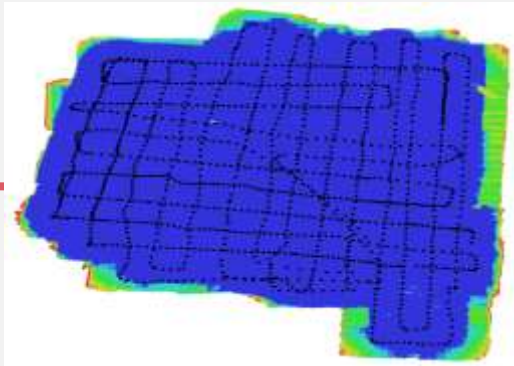
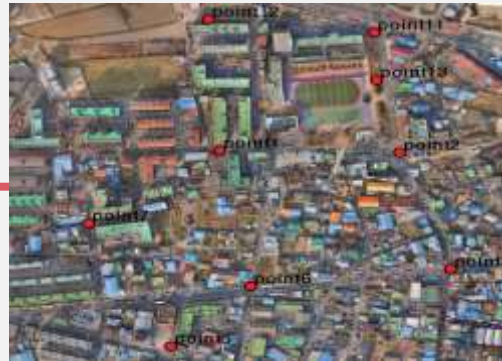
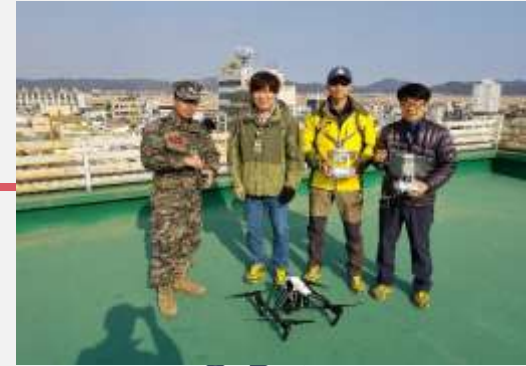
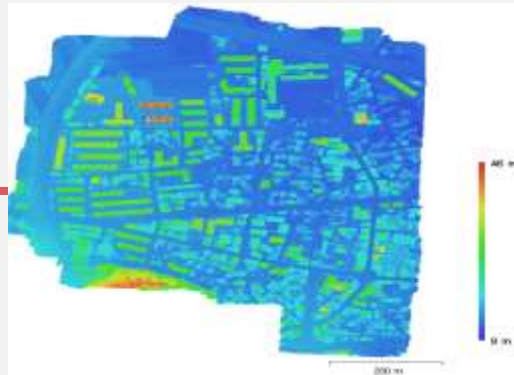
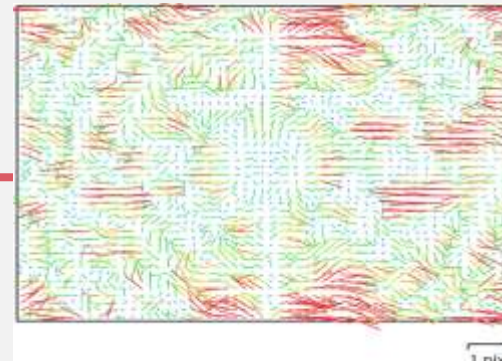
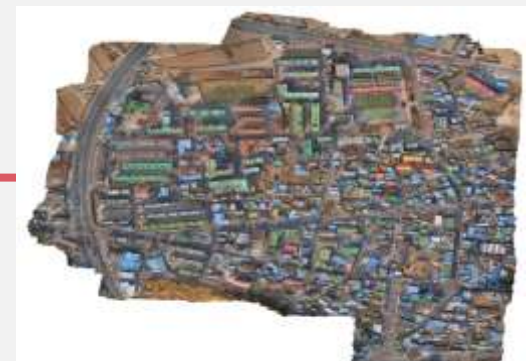
UAV survey procedure

① Planning

② GCP surveying

③ Data collection (flying)

④ Digital Elevation Modeling

⑤ processing

⑥ results

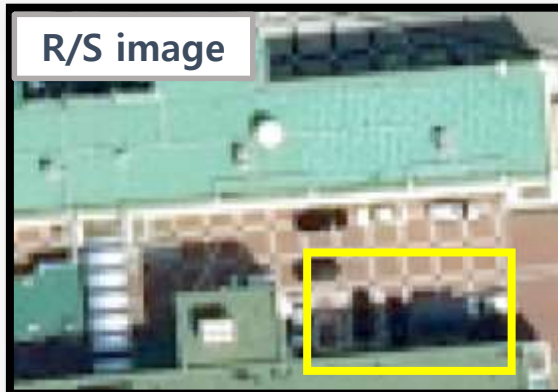
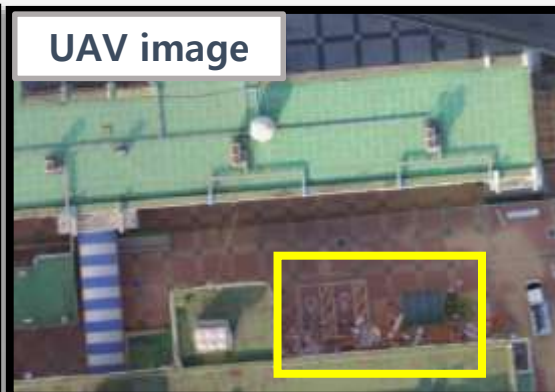
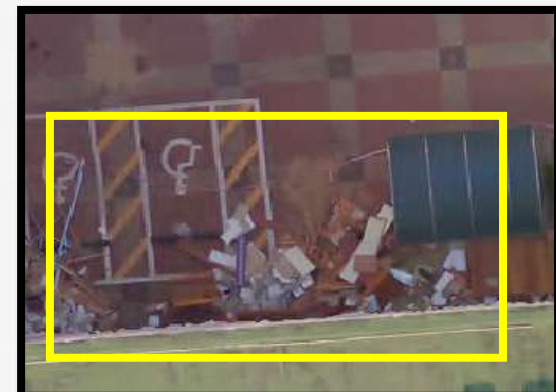
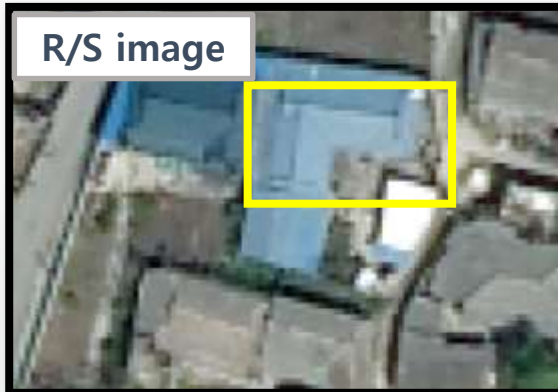
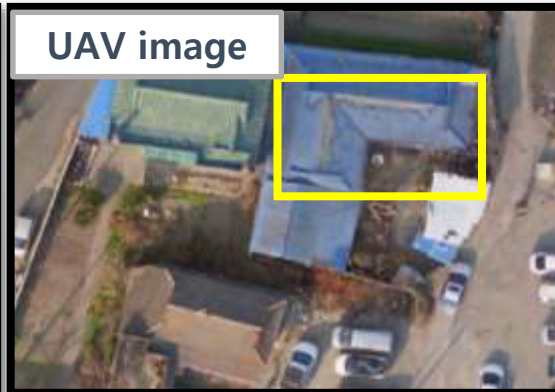
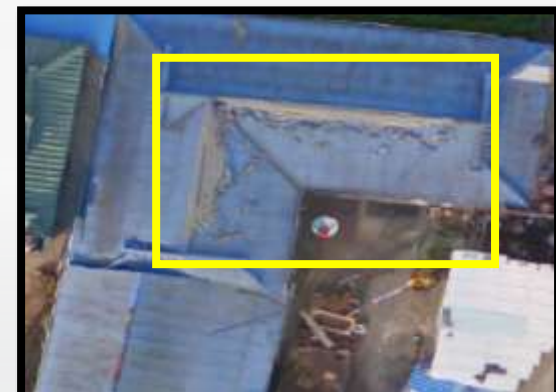
UAV mapping & decipher

It is possible to judge the damage at location where it is impossible to survey
(narrow road, roof) ➡ Offer a few centimeter spatial resolution

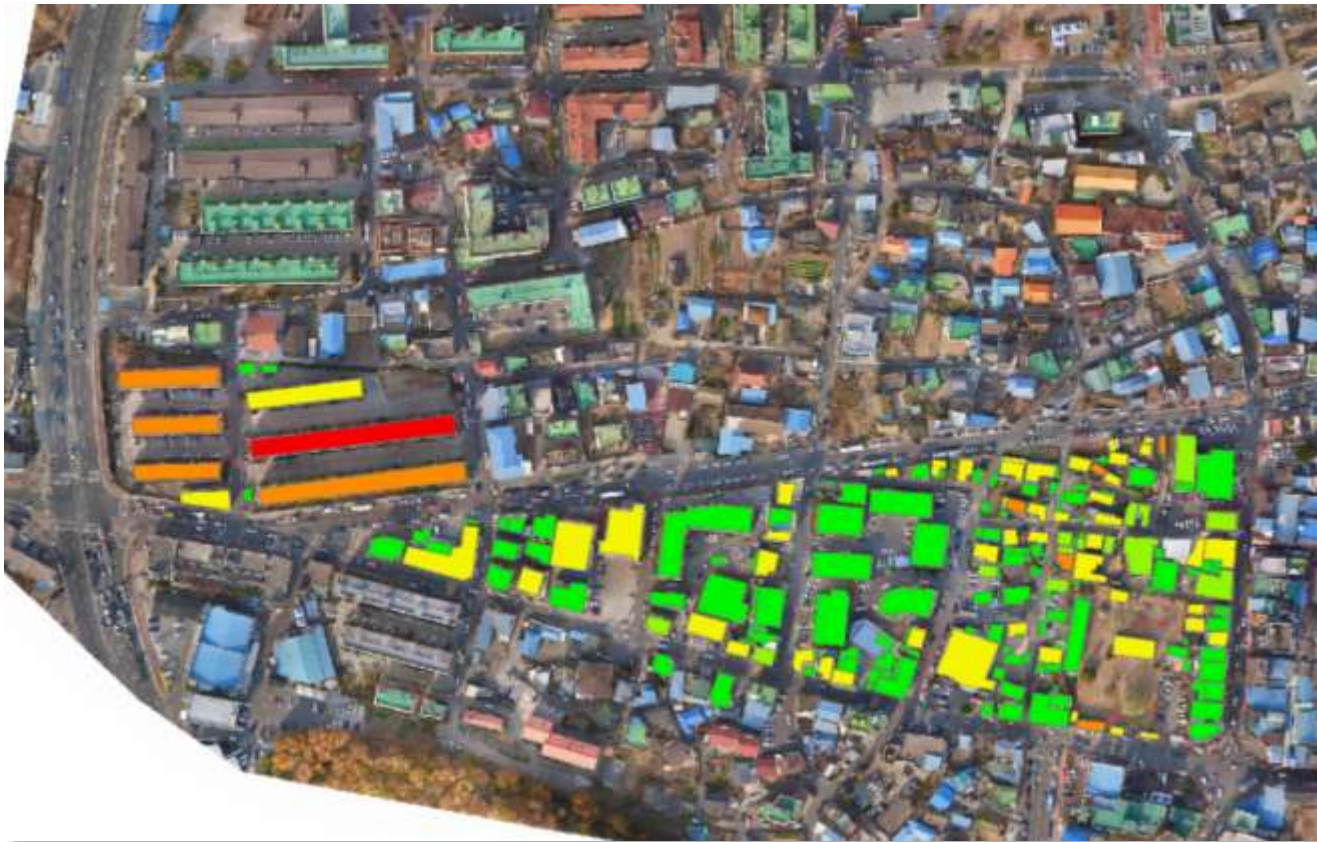
Building damage classification

MMS(slope, well crack, damage) + UAV(well damage, roof damage)

➡ classification about building damage
