MILLIKEN DAM : STRUCTURAL MONITORING OF A CONCRETE ARCH DAM

John F. Paxton ¹

¹URS Corporation, Oakland, CA 94607, USA; E-MAIL: John_Paxton@urscorp.com

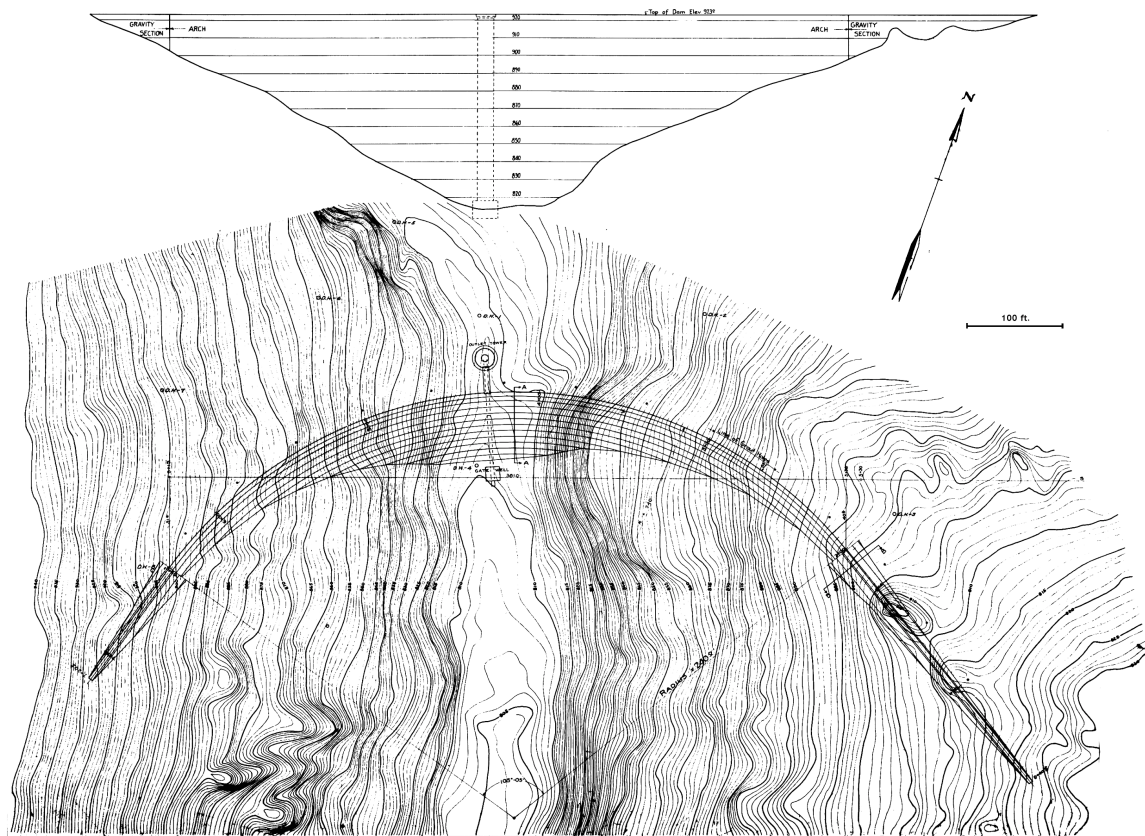
Figure 2. Plan and Profile of dam from original contract drawings.

During first fill in 1925, seepage along approximately six horizontal features identified as cracked or separated lift joints was observed on the downstream face of the dam. Seepage initially described by the DSOD as “very considerable leakage” declined to “minor” by 1931. Cracking in the lower block (inner gorge) section of the dam changed very slowly during the next 25 years according to DSOD inspection reports. Spalling of an approximately 10-foot-long, wedge-shaped block from the lower downstream face was observed by DSOD inspectors in 1954.
