Presented at the FIG Working Week 2016,  
May 2-6, 2016 in Christchurch, New Zealand

# Terrestrial laser scanner for the deformations monitoring and buildings damage

## Case study: Burned industrial building

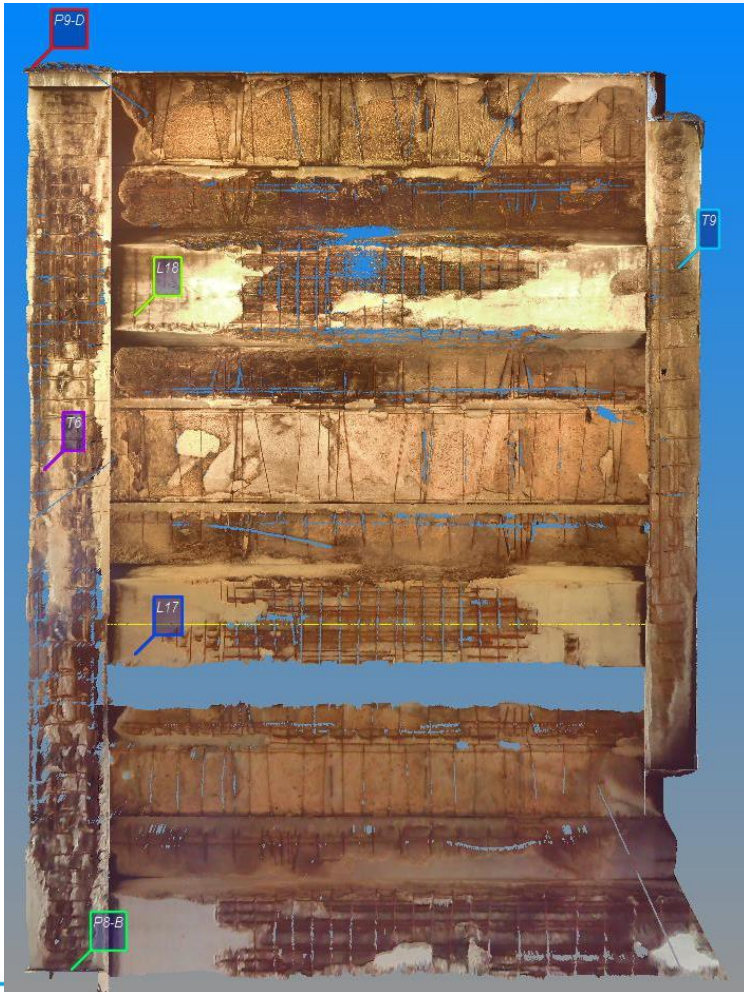
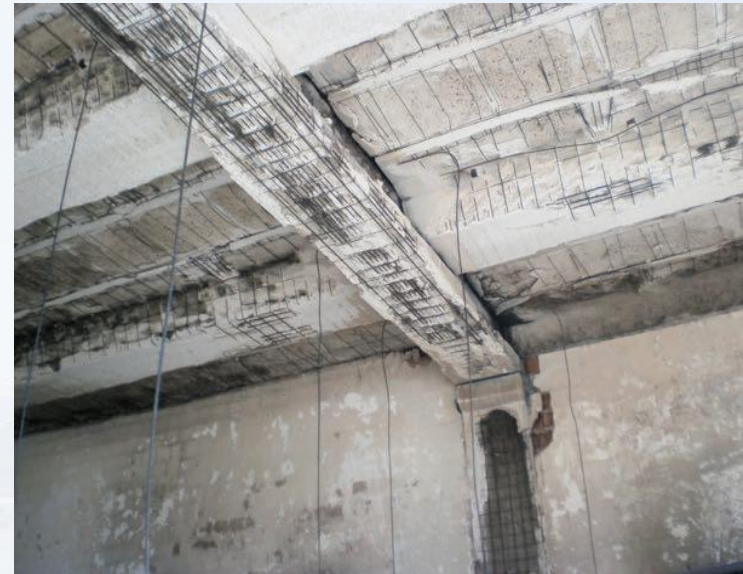
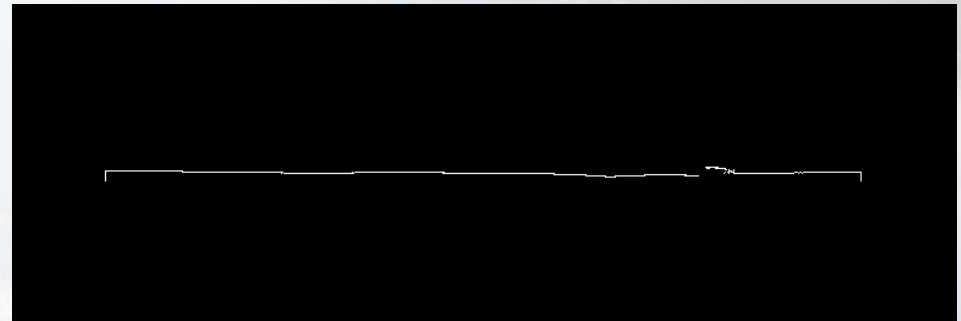
## Beams

Beam	L (m)	v (mm)	y (m)	$\delta$ (mm)	$r_v$ (mm)	$\alpha$ (deg)
L1	12.28	80.70	6.52	14.80	72.84	0.07
L2	12.29	22.10	12.14	24.70	-2.30	0.12
L3	12.25	36.20	12.15	38.20	1.60	0.18
L4	12.23	91.20	8.17	25.40	74.23	0.12
L5	12.26	39.90	7.65	23.60	25.17	0.11
L7	12.21	-23.40	6.97	1.60	-24.31	0.01
L8	12.26	-12.30	9.10	-7.00	-7.10	-0.03
L9	12.25	-14.90	10.32	-10.50	-6.05	-0.05
L10	12.22	-30.90	10.20	-22.00	-12.54	-0.10
L11	12.30	-19.20	3.67	-15.10	-14.69	-0.07
L12	12.24	-23.50	5.80	-7.20	-20.09	-0.03
L13	11.85	-25.20	6.65	-2.60	-23.74	-0.01
L14	11.92	-19.10	6.34	-1.00	-18.57	0.00
L15	11.89	-12.20	5.47	1.60	-12.94	0.01
L16	12.25	-31.00	8.57	-10.60	-23.58	-0.05
L17	5.57	-11.90	0.97	4.80	-12.74	0.05
L18	5.67	-9.10	4.17	-27.00	10.76	-0.27
La	12.23	-36.70	7.97	-13.80	-27.71	-0.06
Lb	12.25	-32.10	9.30	-15.90	-20.03	-0.07
T1	9.20	63.10	8.79	60.10	5.68	0.37
T2	9.33	-28.60	6.22	-0.20	-28.47	0.00
T3	9.35	32.60	8.83	32.60	1.81	0.20
T4	9.35	-11.90	3.65	-17.70	-4.99	-0.11

T5	9.35	31.00	3.75	32.10	18.13	0.20
T6	9.35	-26.00	4.83	-30.30	-10.35	-0.19
T7	9.33	12.00	1.41	15.70	9.63	0.10
T9	6.84	29.80	6.76	30.00	0.15	0.25
