Detection of Service Pipes and the Risk of Collapsing Sinkholes at the Lake of Constance in Switzerland Using Ground Penetrating Radar (GPR)

Edi MEIER, Inma GUTIÉRREZ, Marco BAUMANN, Max BOSSHARD and Rainer HEEB, Switzerland

SUMMARY

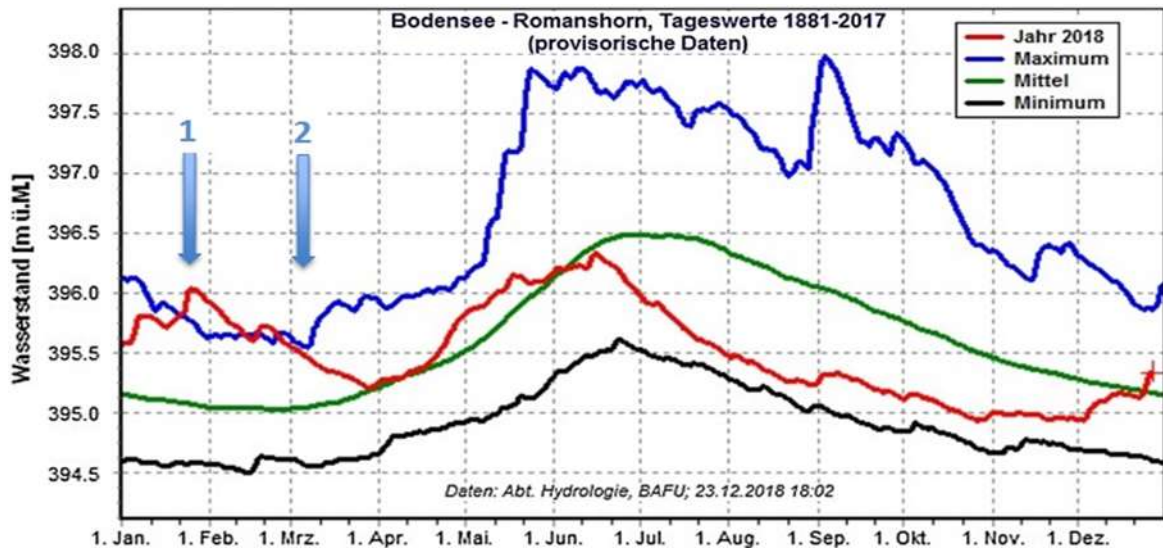
Fig. 2): Water level fluctuation of the Lake Constance since 1881. Red curve = curve for the year 2018, green curve = mean water level, black curve = min. water level, blue curve = max. water level.

During winter 2018 extreme climatic conditions prevailed in the area of the Lake Constance. At the beginning of February the lake water level was higher than the since 1881 measured data (Fig. 2). Driven by a strong north wind big waves lashed to the shore of the promenade. With temperatures below zero the whole area was covered by a dangerous ice shield (Fig. 3 left).

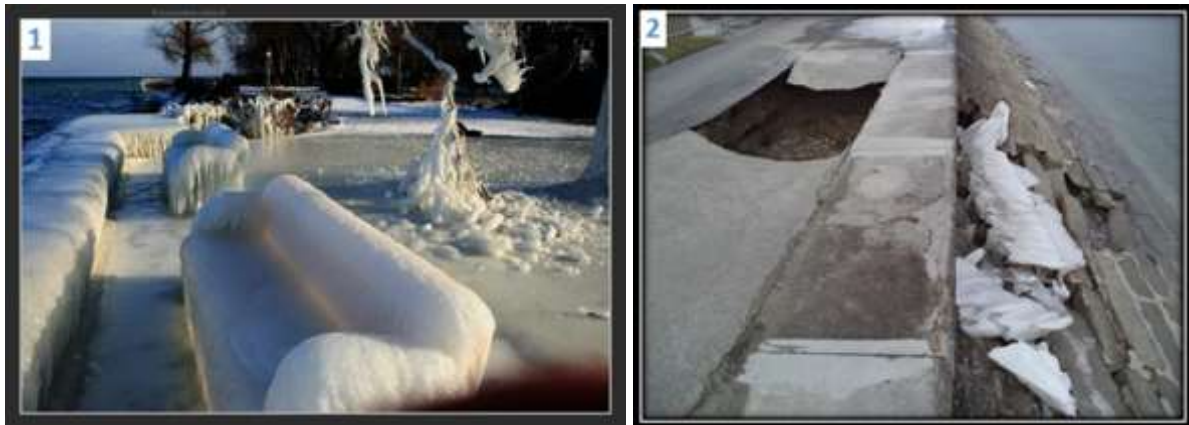
Fig. 3): Ice shield on the shore in February (left) [4]. Collapsed ground after the melting of the ice in March 2018 (right).

One month later, when the ice melted away, the ground under the fairground plaza and under the pedestrian promenade suddenly collapsed (Fig. 3 right). Only the massive retaining wall did not tumble down and formed a bridge (Fig. 4 left). Apparently, the poor condition of the shore ramp and the high water level - in combination with the strong north wind - was the cause for the soil erosion. The lakewater could penetrate through openings and cracks in the wall (Fig. 4 right) and loosened the ground when freezing.

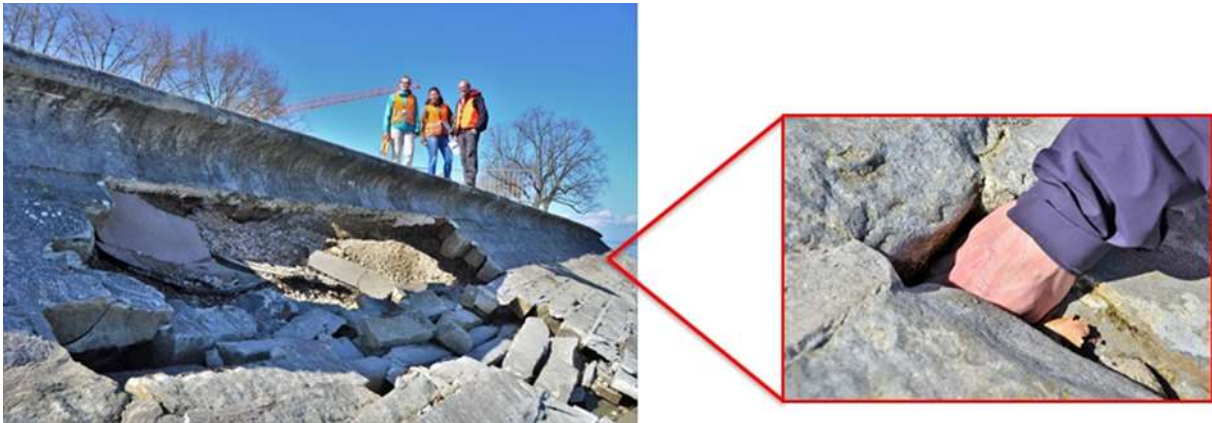
Fig. 4): Collapsed site near the promenade (left). Holes between the stones in the ramp (right).

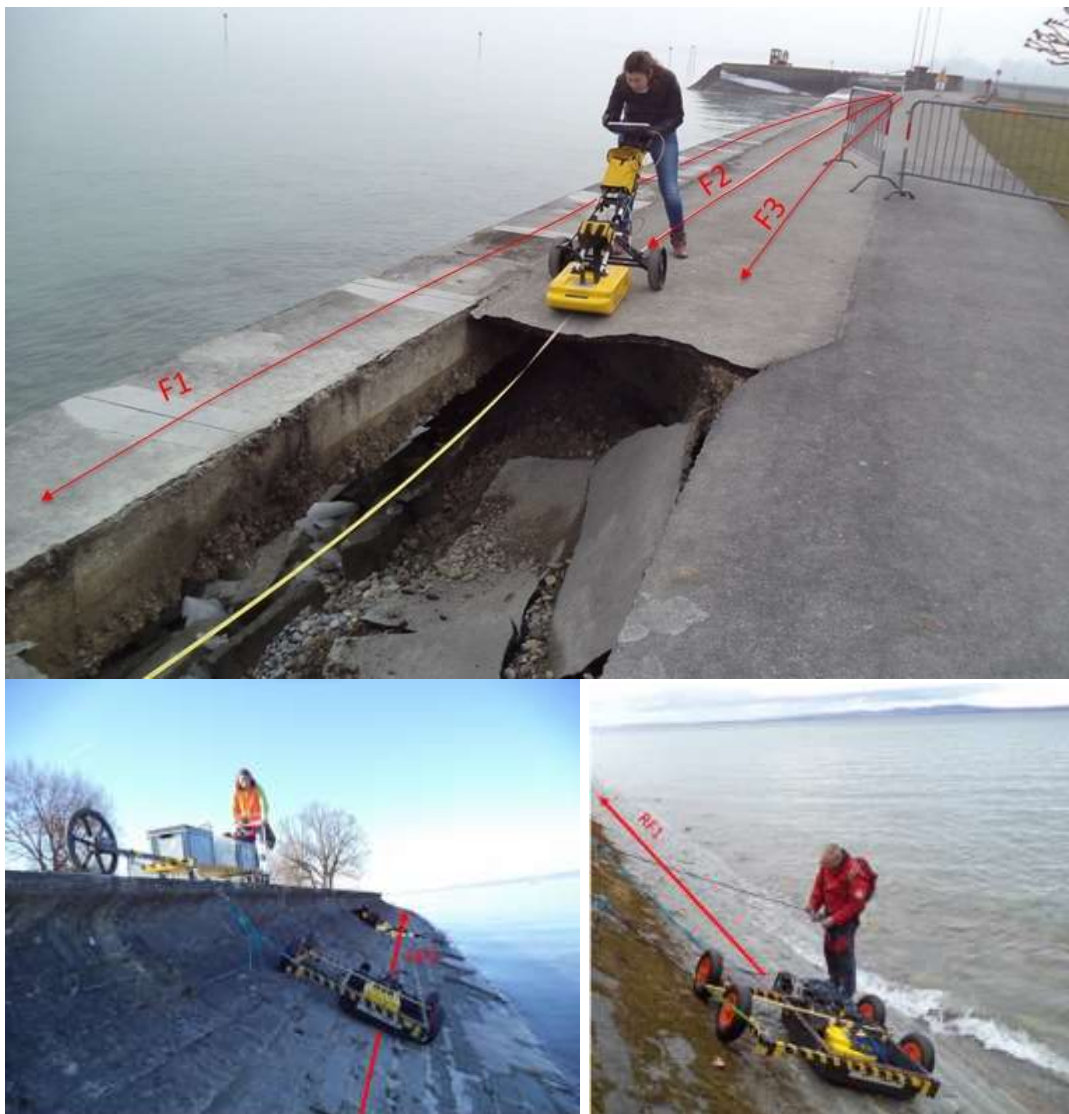
Two areas were investigated: the pedestrian walkway and the fairground plaza, both with associated ramp. The measured data were collected in five parallel rows. During the first measurements, there were still a few icy places on the shore. A GPR system with shielded 250- / 700-MHz double antennas was used (Fig. 5 above).

Fig. 5): GPR shots along the promenade: Three profiles on top of the path, view towards the fairground plaza (top picture), two profiles on the ramp wall, view in the opposite direction (pictures below).

A week later the two profiles on the shore ramp were executed. For this purpose, two carriages were built, a guiding carriage for the quay wall and a carriage for the ramp wall. They were fixed together with a rope-system.

The guiding carriage was equipped with a precision trigger wheel. This released a measurement every 5 cm interval. The carriage with the radar antenna on the ramp wall was pulled with the same speed as the guiding carriage. Thus, the metering of the ramp profiles is always comparable to that of the profile F1 on the quay wall.

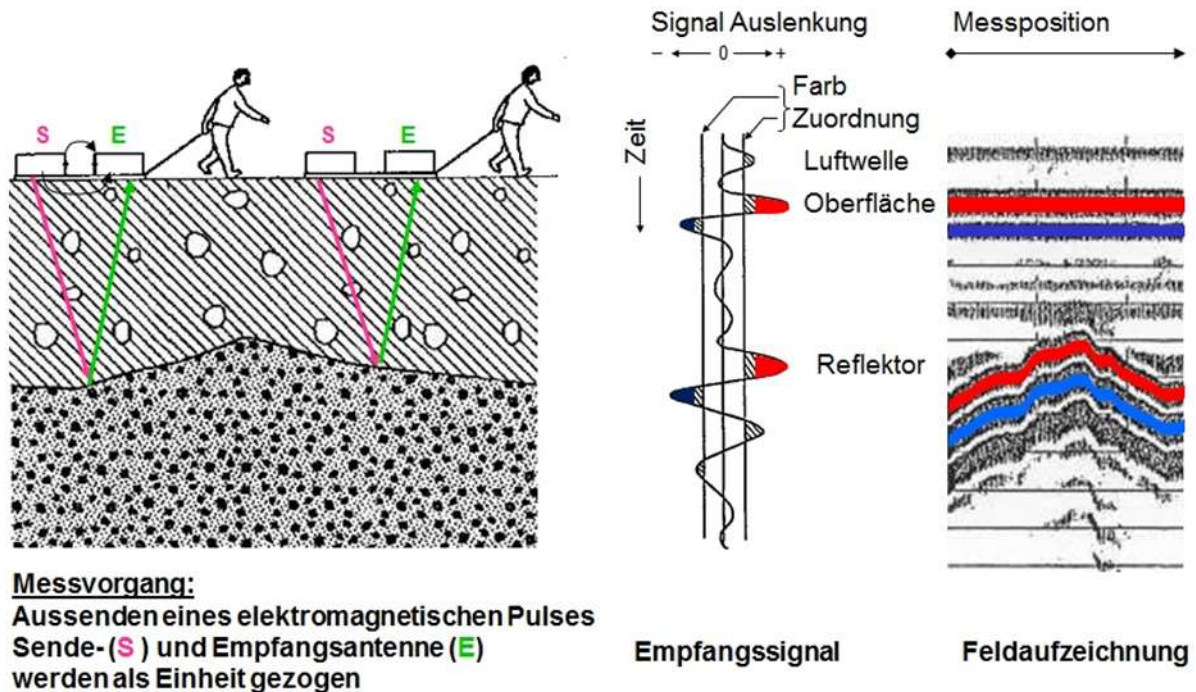
A radar pulse is emitted from the transmission antenna into the ground, which is reflected at interfaces of rock packages or layers in the underground (Fig. 6). Thereafter, the pulse returns to the receiving antenna where it is recorded. The time that elapsed between transmission and reception of the pulse provides information about the depth of the object (reflector). The strength of a reflection serves as a clue to the electrical properties of the material that caused the reflection.

Fig. 6): Principle of GPR measurement (Meier E. et al., 2002)

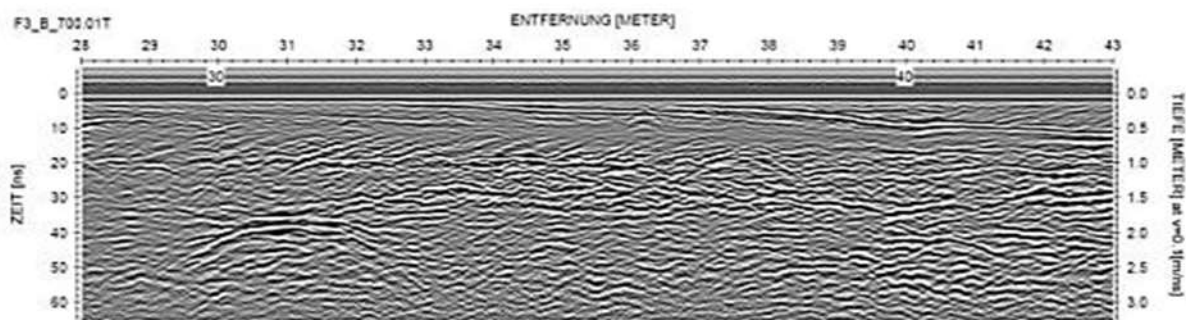
The “radargrams” recorded on the pedestrian path show clear structures up to about 4 m depth. Profile F3 was taken at a distance of 2 meters parallel to the quay wall. Figures 7 and 8 show the same section as profile F3, but were recorded with two different frequencies. While the 700 MHz antenna shows smaller structures (Fig. 7), the 250 MHz antenna achieves greater depth penetration (Fig. 8).

Fig. 7): Part of profile F3, taken with the 700 MHz antenna.

On both pictures is the same structure clearly visible: a structure up to 1 m depth, that slopes to the left, is seen on the left half on the “radargram” as well as the departure tracks of the construction machines on the right half.

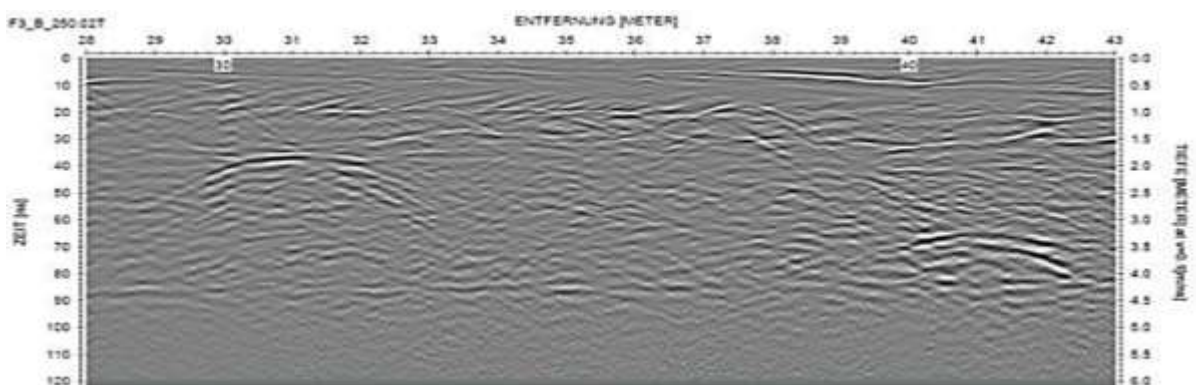
Fig. 8): Part of profile F3, taken with the 250 MHz antenna.

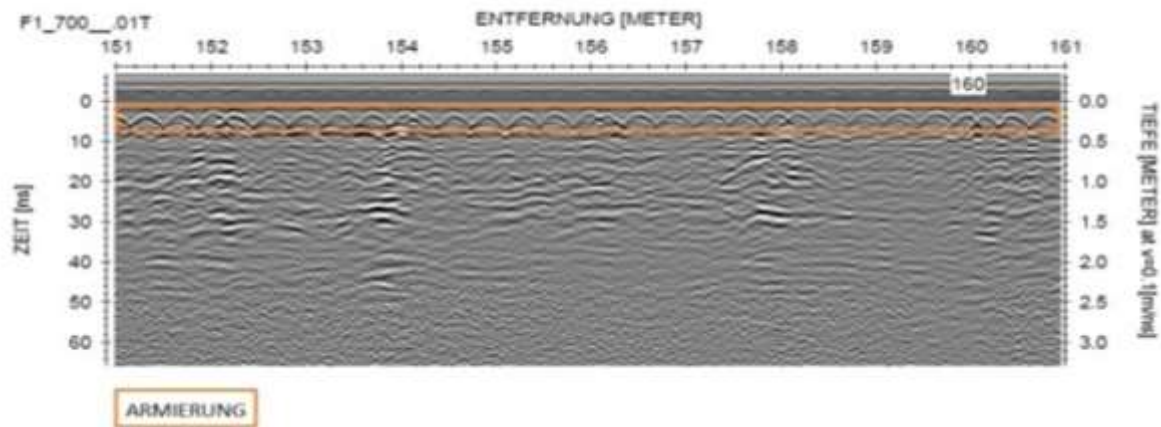
receiving antenna. In the “radargram” it is displayed perpendicular to the profile. This leads to the above-mentioned “bow shape” (hyperbolas). This can be seen on the “radargram” of profile F1 taken on the Quay wall: there is a regular pattern of hyperbolas (Fig.9). Four transverse reinforcing bars per meter create this pattern. The hyperbolas in the “radargram” simulate a continuous arcuate support structure, that certainly does not correspond to the reality. In fact, the “reinforcing bars” are likely to be only a few cm in width.

Fig. 9) Part of profile F1 on the quay wall, taken with 700 MHz antenna. Reinforcing bars draw hyperbolas in the “radargram”. At the apex of each hyperbola is a “reinforcing bar” in transverse direction to the profile.

To correct these "artefacts" the geophysical processing method "migration" is used. This method recalculates the hyperbola branches to a circle, the actual origin of this object. However, migration only makes sense if the hyperbolas cover underlying structures or if steep structures are present. We recommend to keep the hyperbolas in the “radargram” and to analyse them. The position and depth of the object can be determined just as well without migration, because the objects are always at the vertex of the hyperbola.

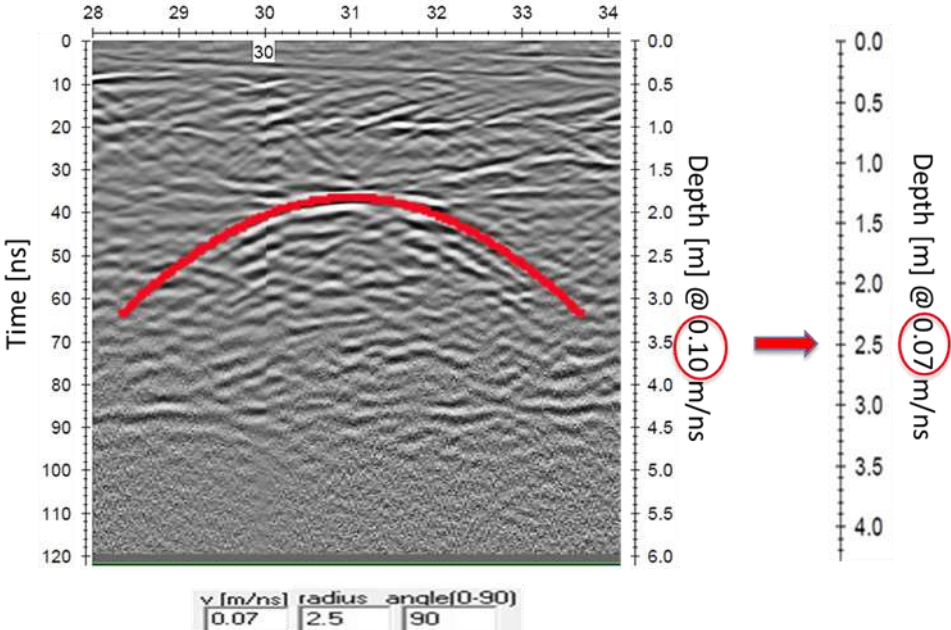
As an example, the analysis of the object in 2 m depth at profile position 31 m in the radar profile F3 is shown in Fig. 10.

Fig. 10): Model hyperbola adapted to the object in Fig. 8. The depth scale on the right corresponds to the calculated speed of 0.07 m/ns adapted in the model.

The model hyperbola gives a speed of 0.07 m/ns. The depth scale must therefore be corrected at this point by a factor of 0.7. This slower speed indicates that clayey material has been deposited over the object. The model calculation of the value of the diameter of the object gave a result of 2.5 m. However, it could also be an elongated object (pipe) cut at a shallow angle. This would result in a comparable flat model hyperbola. Since the object is not seen in the neighbouring profiles, this interpretation is much more likely. A cavity washed out by the lake can thus be excluded.

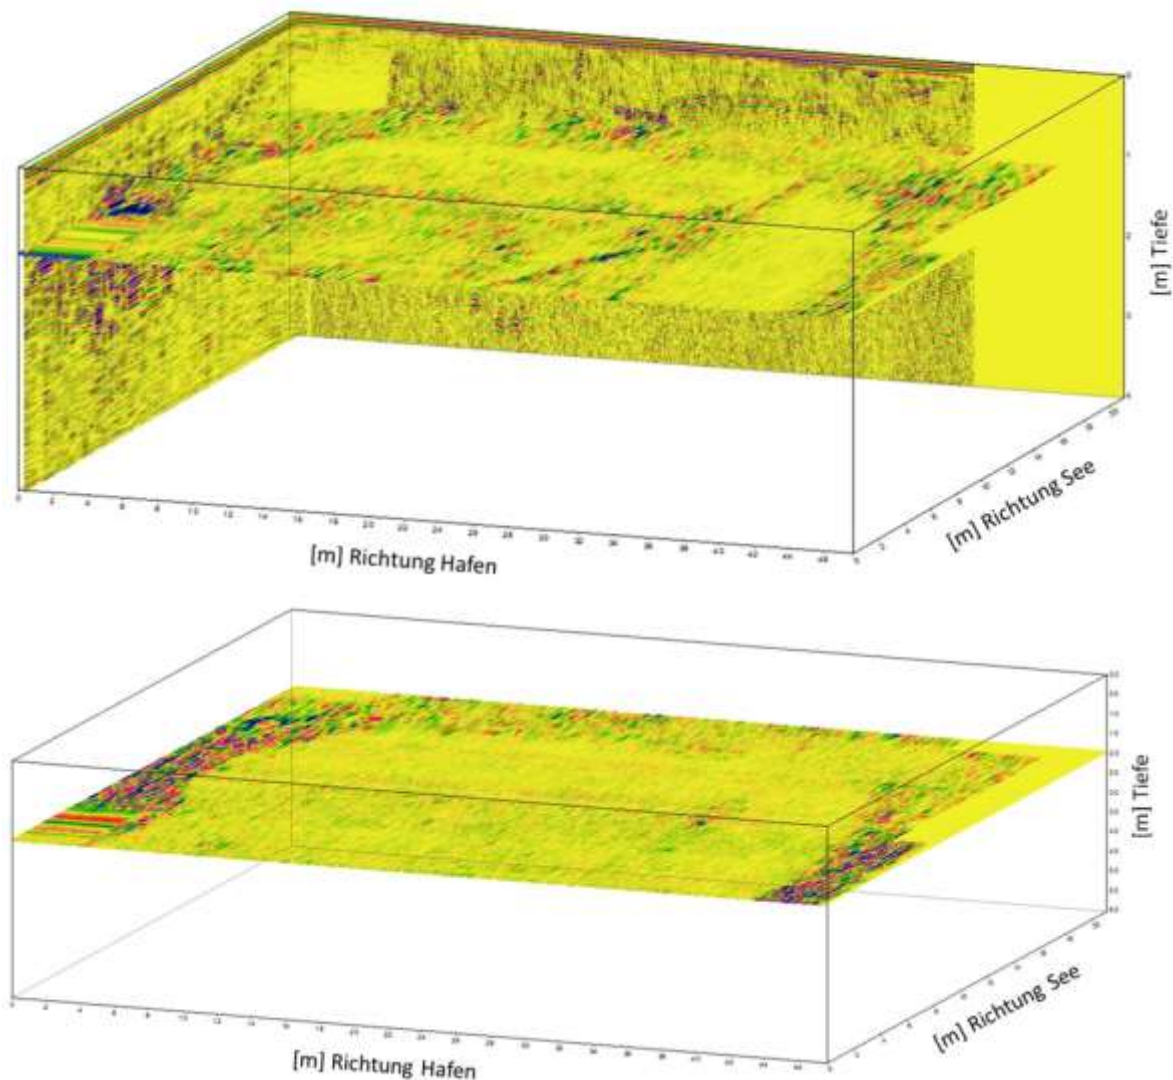
The 50cm line grid recorded on the fairground plaza allows both a 3-D interpolation of the ground in the longitudinal and transverse directions as well as a plane representation with depth (see Fig. 11). These pictures are “put together” in the form of a film document. It can be played on any video player program and stopped at any depth. In the plane view, in 1.1 m depth, lines (=pipes) can be seen, which are shown as a “Y-shape”. At a depth of 2 meters you can see a dense track in the middle of the area and at the margin a deposit of landfill material is assumed, because all the area is artificially filled up. On the basis of these findings, dredging slits were executed to corroborate the interpretation.

Fig. 11): 3-D images: In the plane view, lines are visible as a „Y-shape“ in 1.1 m depth. The lower picture shows the level at a depth of 2 m. Here, especially on the left and right side of the area, there are highly reflective zones.

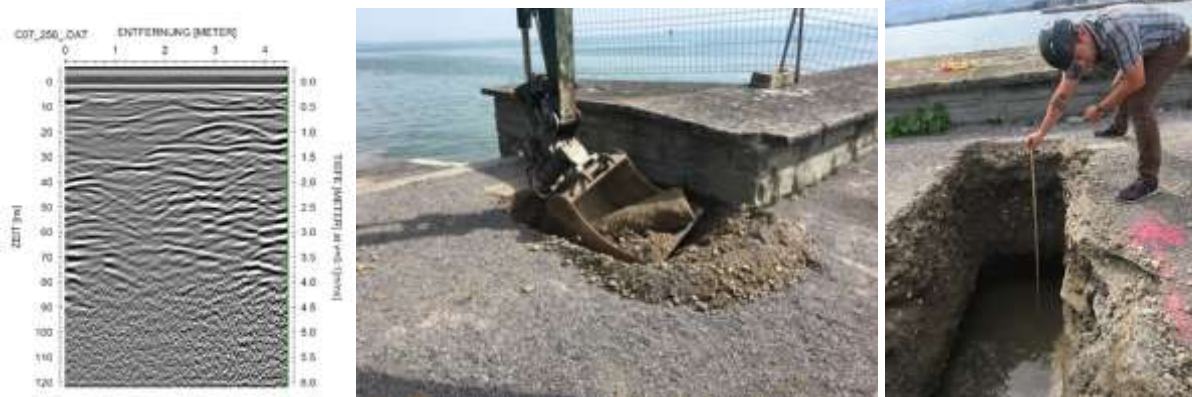
The dredging slits to the left and right of the site did not show the expected clayey landfill material. At first a large block of stone appeared, which caused the hyperbola (Fig. 12, left and center). Below the stone there followed potato-sized, round stones without finely granulated material. Water immediately flowed through the large cavities between the stones, (Fig. 12, right), which explains the change in the reflection signals at a depth of 2 meters. This shows that there is a rapid hydraulic connection to the lake water on the edge of the plaza and that a lot of fine grained material from the original fill is washed out. With great certainty it could be ruled out that the ground on the plaza would suddenly collapse. At the most, slow subsidence can occur when more fine grained material is washed out.

Fig. 12): The Profile C7 has a distinct hyperbola (picture left). The excavation brings out a large stone block (middle picture). The remaining excavated material consists of round stones of 3 - 5 cm diameter with little finely granulated material. The water flows immediately (picture right).
