# **Geodetic Measurements for Detecting Movements on the Structure Surface Due to Mining Activities**

**Eray CAN, Senol KUSCU, Cetin Mekik**

**Bulent Ecevit University**

**FIG Working Week 2012  
Rome, Italy, 6-10 May 2012**

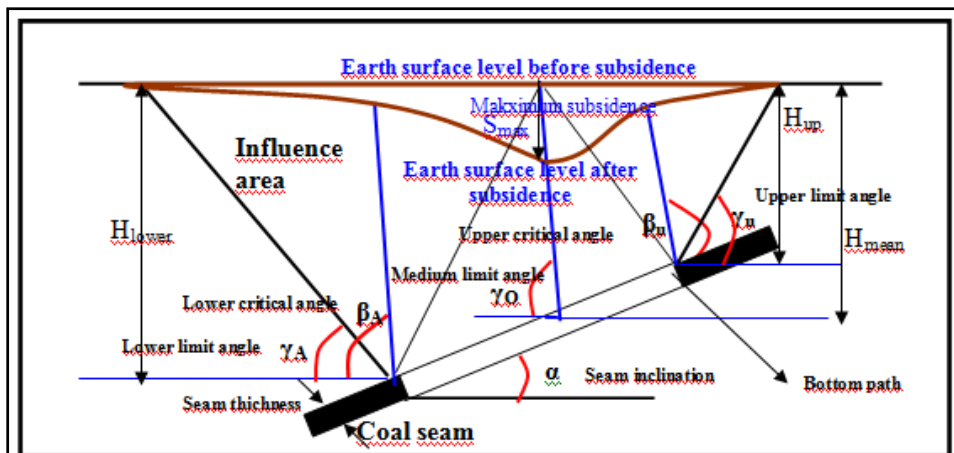
Figure 2. Subsidence tub forming after production in inclined coal seams and the other related definitions (Kratzsch, 1983).

Fig 2 depicts the subsidence formation and its influence areas after mining activities in inclined coal seams in the region.

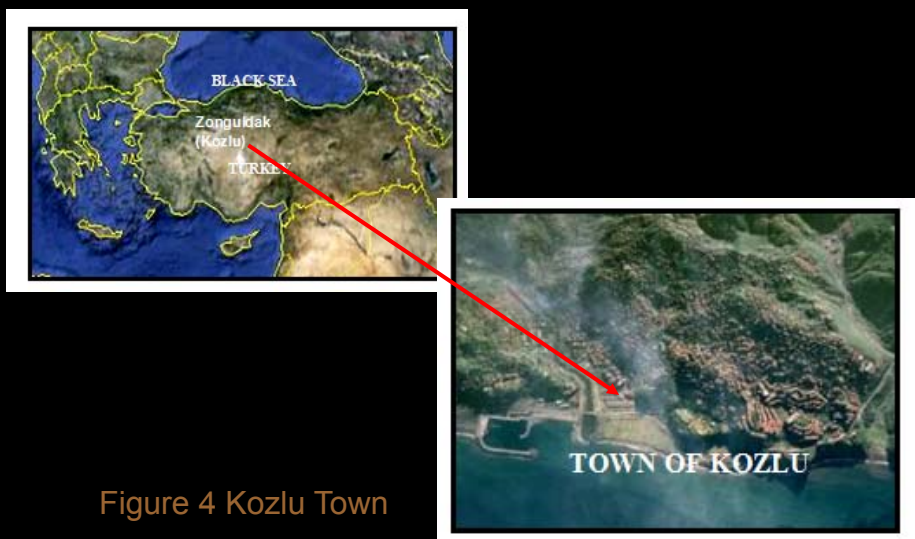
Kozlu is located in the Western Black Sea Region of Turkey at latitudes  $41^{\circ}-27'$  N and longitudes  $31^{\circ}-49'$  E (Citiroglu and Baysal, 2011). (Figure 4)
